# Sample Trend

Database: FA-ST BOATCARE	Equipment: E10 - CRANCHI 37 FOXY JO
Area: C519 - BOATCARE YACHT SURVEYS (C)	Point: P2 - STBD ENGINE KAD 300-285HP

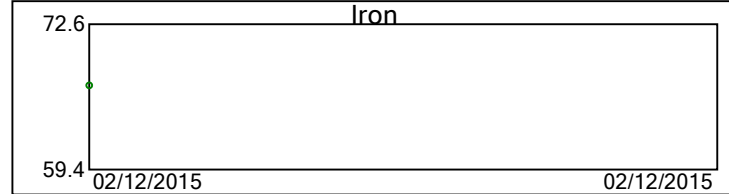
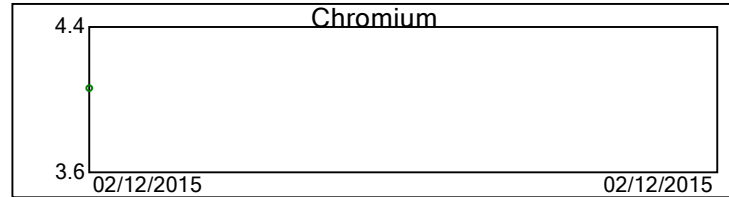
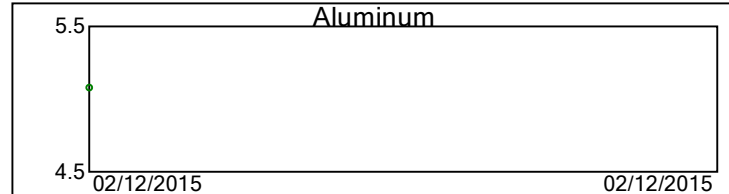
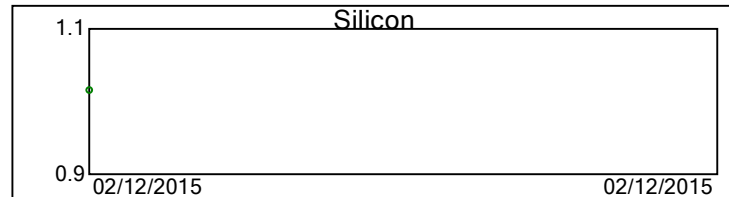
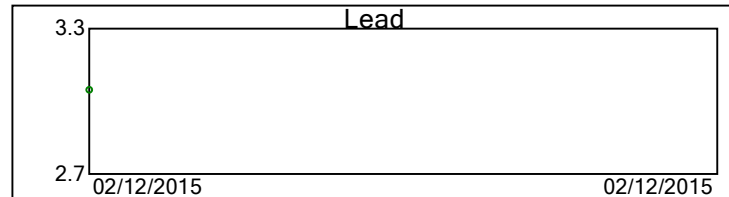
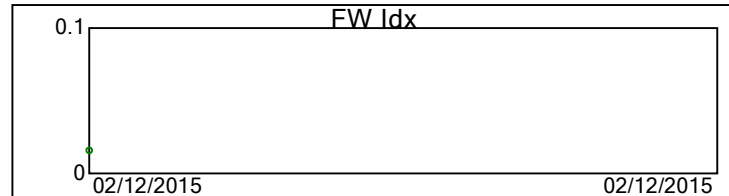
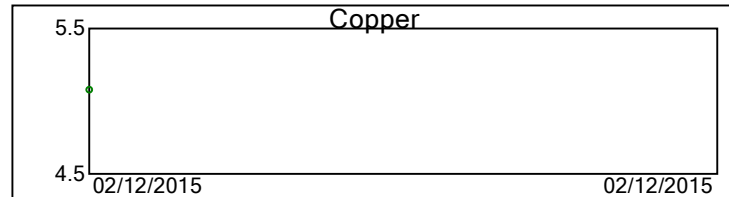
<b>Wear</b>	<b>0</b>			
Aluminum	5.00			
Chromium	4.00			
Copper	5.00			
Iron	66.0			
Lead	3.00			
Nickel	4.00			
Silver	0.00			
Tin	2.00			
Titanium	0.00			
Vanadium	0.00			
FW Idx	0

WEAR READINGS LOOK OK. RESAMPLE AS NORMAL.
